# A Lesson in Lock Out Tag Out from Phillips 66 Disaster

An Online Continuing Education Course for Engineers

**Course Number: ED-1002**

Jeffrey S. Caudill, P.E.

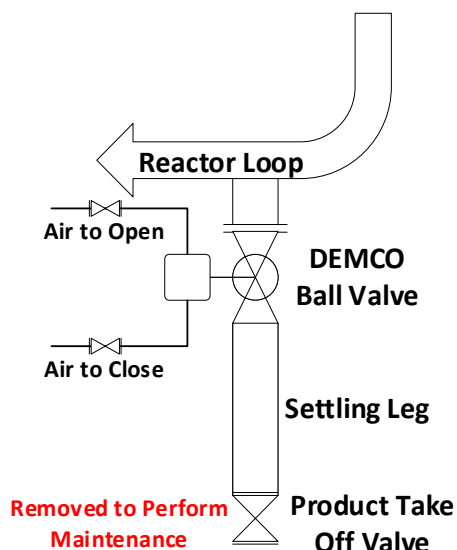
The Phillips process utilized six settling legs on each reactor. These settling legs routinely plugged off, requiring contractor maintenance crews to isolate the legs and clear the blockage.
