6 Hours from Catastrophe – The Hartford Civic Center Collapse

An Online Continuing Education Course for Engineers

Course Number: ED-2002

James Bluma, P.E.

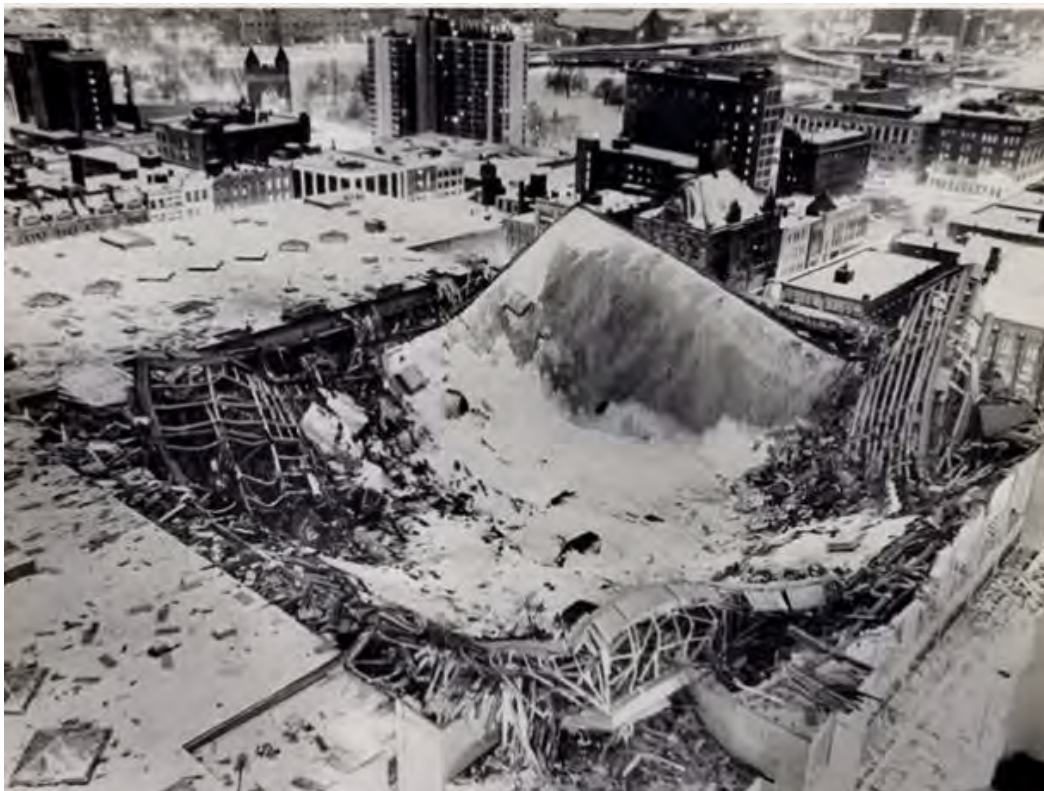
On January 18, 1978 at 4:19 AM, in what could have been one of the worst structural failure disasters in history, the roof of the three-year-old Hartford Civic Center Arena suddenly collapsed. Six hours earlier, the arena had been filled with 4,746 basketball fans watching a University of Connecticut versus University of Massachusetts basketball game. So sudden and complete was the failure that the 2 ½ acre, 2,900-ton roof fell the 83 feet to the arena floor and seating areas in only a few seconds from the time security guards in the retail area heard a loud crack. The mass of steel, lighting, and gypsum cement falling onto such a closely assembled crowd would likely have caused hundreds or thousands of fatalities had the incident occurred only a few hours earlier that evening. At the time of the collapse the building was unoccupied, and the failure caused no injuries.

Below, Figure 1: Aerial view of the Hartford Civic Center roof on January 18, 1978.

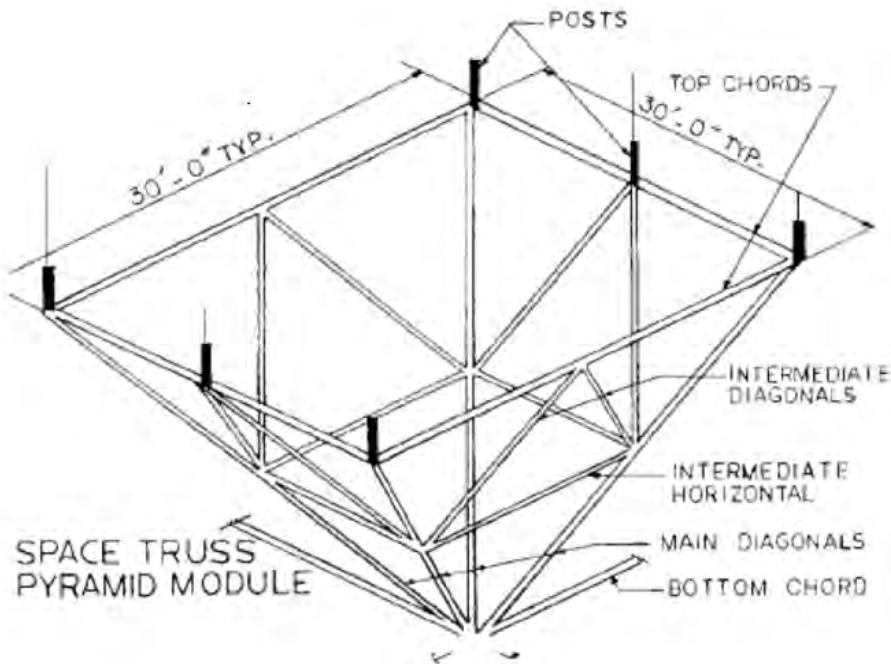
Below, Figure 3: Typical pyramidal truss module layout as built in Civic Center space frame.

In addition to the flawed choice of a cruciform cross section for the truss bars, the LZA investigation discovered that no horizontal mid-point braces were provided for the members in the top layer, see Figure 3. The exterior top chord members were only braced every 30-feet rather than the 15-foot intervals that had been modeled and specified by F B Y and the interior members were only partially and insufficiently braced at their midpoints. The two members attached to the midpoint of the top chord were both in the same plane as the long axis of the chord meaning that they could only provide bracing in one direction. The perpendicular direction was effectively un-braced for the full 30-foot length, see Figure 3.
