A Lesson for Learning from the Lemoore City Water Tank and Other Hot-Work Related Tank Explosions

Course Number: ED-3005

By: Jeffrey S. Caudill, P.E.

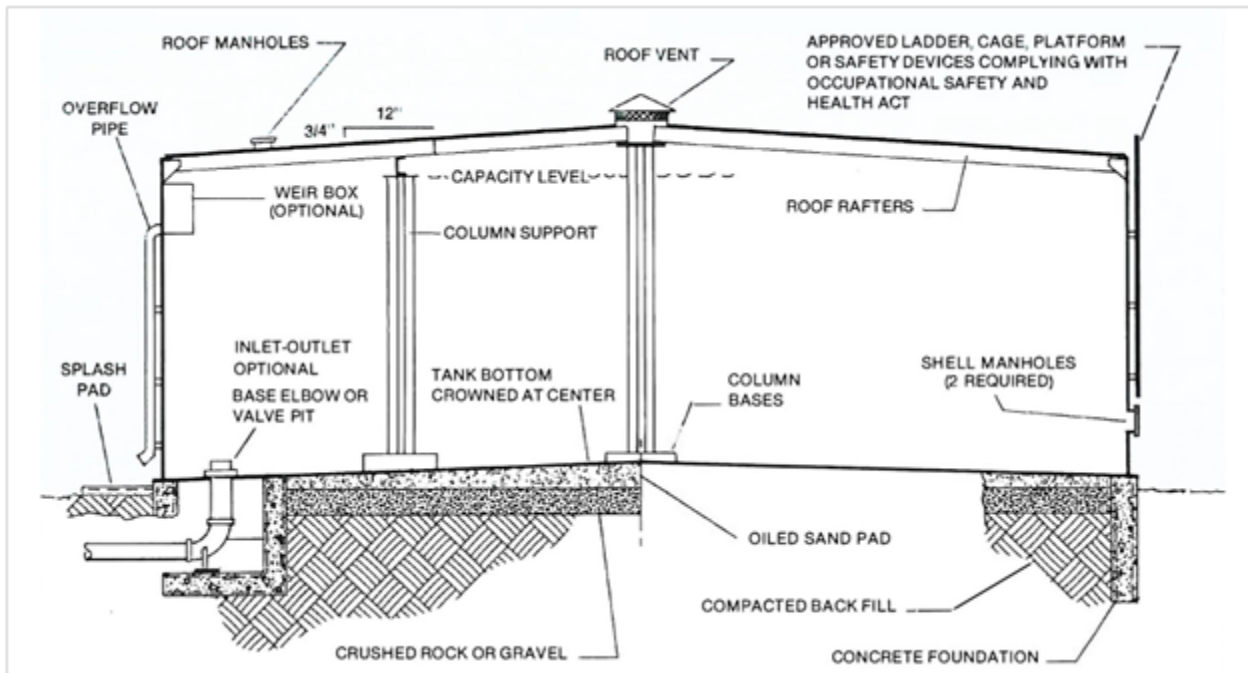
Figure 1: Typical Atmospheric Water Tank Cross Sectional View by creative commons CC BY-SA, modified by J. Caudill

The drawing below is a typical cross-section of an above ground water storage tank. The Lemoore City water tank was not a large enough diameter tank to require intermittent column supports for the roof trestle support beams. Additionally, the overflow drain did not have a weir box installed. Lastly, the Lemoore City water tank had a flatter slope on the bottom of the tank. There are most likely other minor differences, however the form and function and structural-mechanical design were similar to the graphic we are sharing.

The drawing depicts some key visual information that assists in explaining the venting on this type of closed cone roof tank. Additionally, because the tank is welded steel plate, we know there are two key welds involved with this tank. These welds are *ring-wall to floor-plate* and *roof to side-wall*.

There is nothing to suggest that the center vent on the Lemoore City water tank was blocked, either on purpose for maintenance or through other causes. Additionally, venting can occur through the overflow line that is attached near the top fill line of the tank. Tanks vent air and any other gases like methane when filling and vacuum air into the tank when draining.

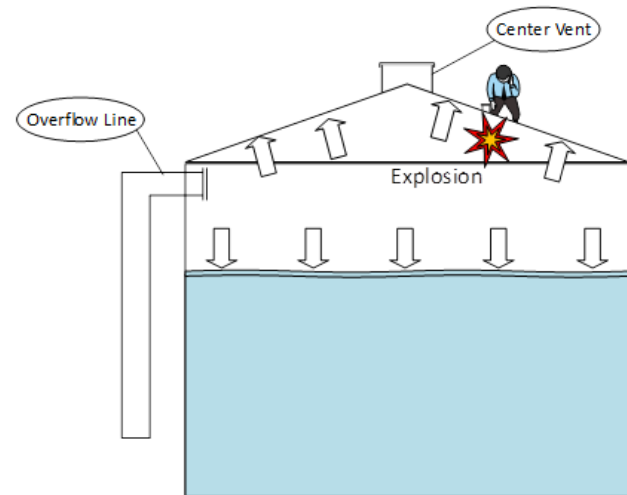
Figure 2: Lemoore Water Tank Explosion Graphic by J. Caudill.

As shown in this simple drawing (Figure 2), when the explosion occurred (deflagration), equal forces pushed the roof upward and the water inside downward. Due to the design of this particular tank, the roof was not equipped with an explosion hatch nor a breakaway roof designed to come off during an explosion. This meant the downward force of the blast, plus the weight of the water inside, placed the greatest pressure forces at the ring-wall to floor-plate weld. The weld seam broke free from the floor plate. This is confirmed in the video as the intact roof, and side walls are torn from the floor plate, leaving it essentially in-situ. Without the video surveillance, most would assume that the roof would have torn partially open or blown completely off.
