Titanic – A Materials, Design, and Safety Failure

An Online Continuing Education Course for Engineers

Course Number: ED-4001

R. Prakash Kolli, P.E., PhD

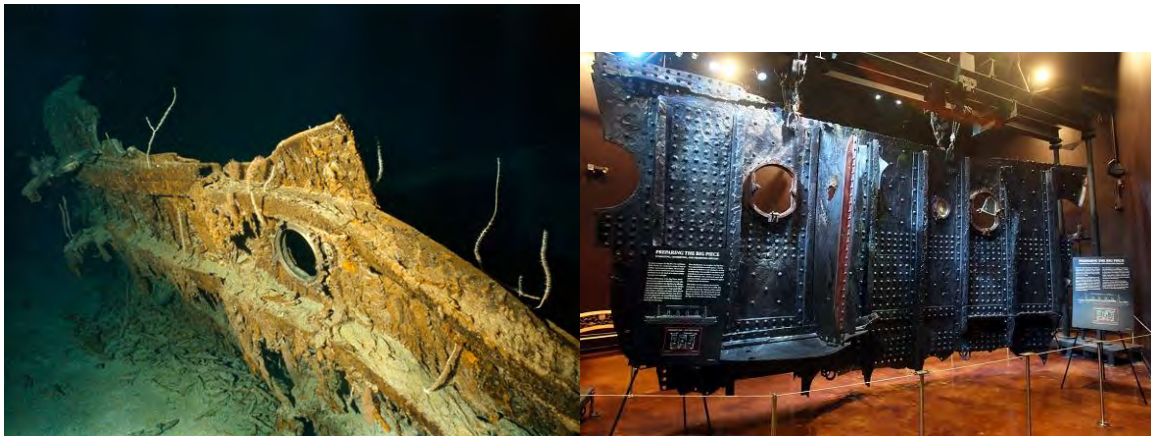
Figure 2. (Left) An approximately 20-ton section known as “The Big Piece” sits on the ocean floor before it was recovered. (Right) A 17-ton segment of the same section that is on display at the Luxor Las Vegas hotel and casino.
