Engineering Ethics: Kansas City Hyatt Walkway Collapse

An Online Continuing Education Course for Engineers

Edward P. Brunet, Jr., P.E.

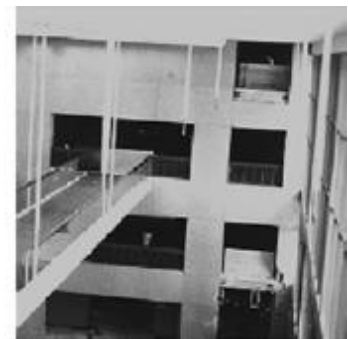
The proposed Kansas City Hyatt Regency Hotel consisted of three sections: a 40-story tower section, a function block, and a connecting atrium. The atrium, where the accident occurred, is a large open area approximately 117 feet wide x 145 feet long x 50 feet high. Three suspended "skywalks" spanned the atrium at the 2nd, 3rd and 4th floor levels. The 3rd and 4th floor walkways were each suspended from the atrium roof trusses, while the 2nd floor walkway was located directly underneath the 4th floor walkway and was suspended from the 4th floor walkway (see Figure 1 after the collapse showing the dangling 4th floor walkway rods to the right in the picture).

Figure 1. Third Floor Walkway (left)

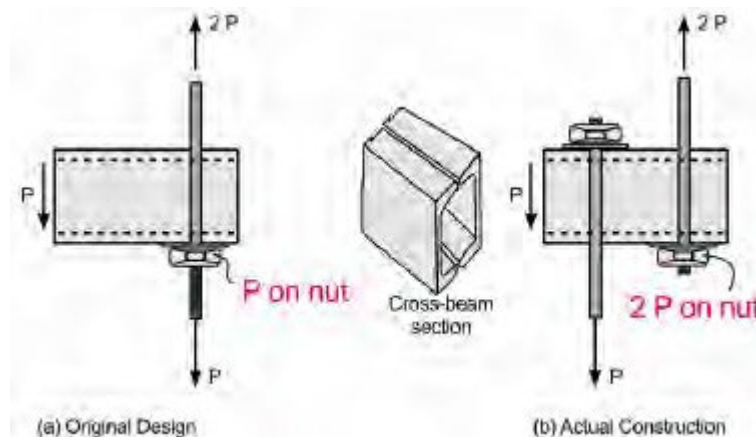
The box beam members that formed the lateral structural support for each walkway were comprised of two (2) 8 x 8.5 MC channels welded toe-to-toe (see Figure 2a).

Figure 2 – 4th Floor Atrium Walkway Box Beam Connection Detail

Therefore, Havens changed from a single to a double hanger rod box beam connection at the 4th floor catwalk (see Figure 2b). A rod was hung from the ceiling down to the 4th floor walkway. And a second rod was hung from the 4th floor walkway down to support the 2nd floor walkway. This allowed the use of shorter rods, which were readily available. It also simplified the erection process and eliminated the need for the entire rod to be threaded.

Because of the double rod design change initiated by Havens, the load at the nut on the 4th floor upper rod section was twice the load of the original single rod design. The investigation discovered that the original design could only support 60% of the load required by the building code. The shop drawing change to a two rod design doubled the load at the 4th floor connection, meaning that the as-constructed connection could only bear 30% of the mandated load.

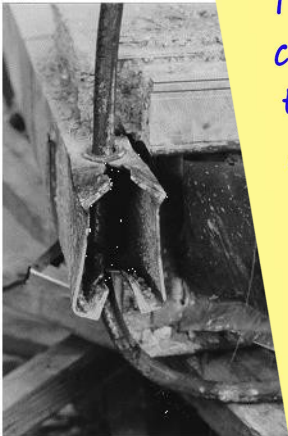
Figure 3 - Fourth Floor Box Beam Connection. The rod slipped through the box beam, resulting in the collapse of the walkway (see Figure 3).
