Explosion in New Jersey: How a Small Amount of Water Proved Deadly

An Online Continuing Education Course for Engineers

Course Number: H-3006

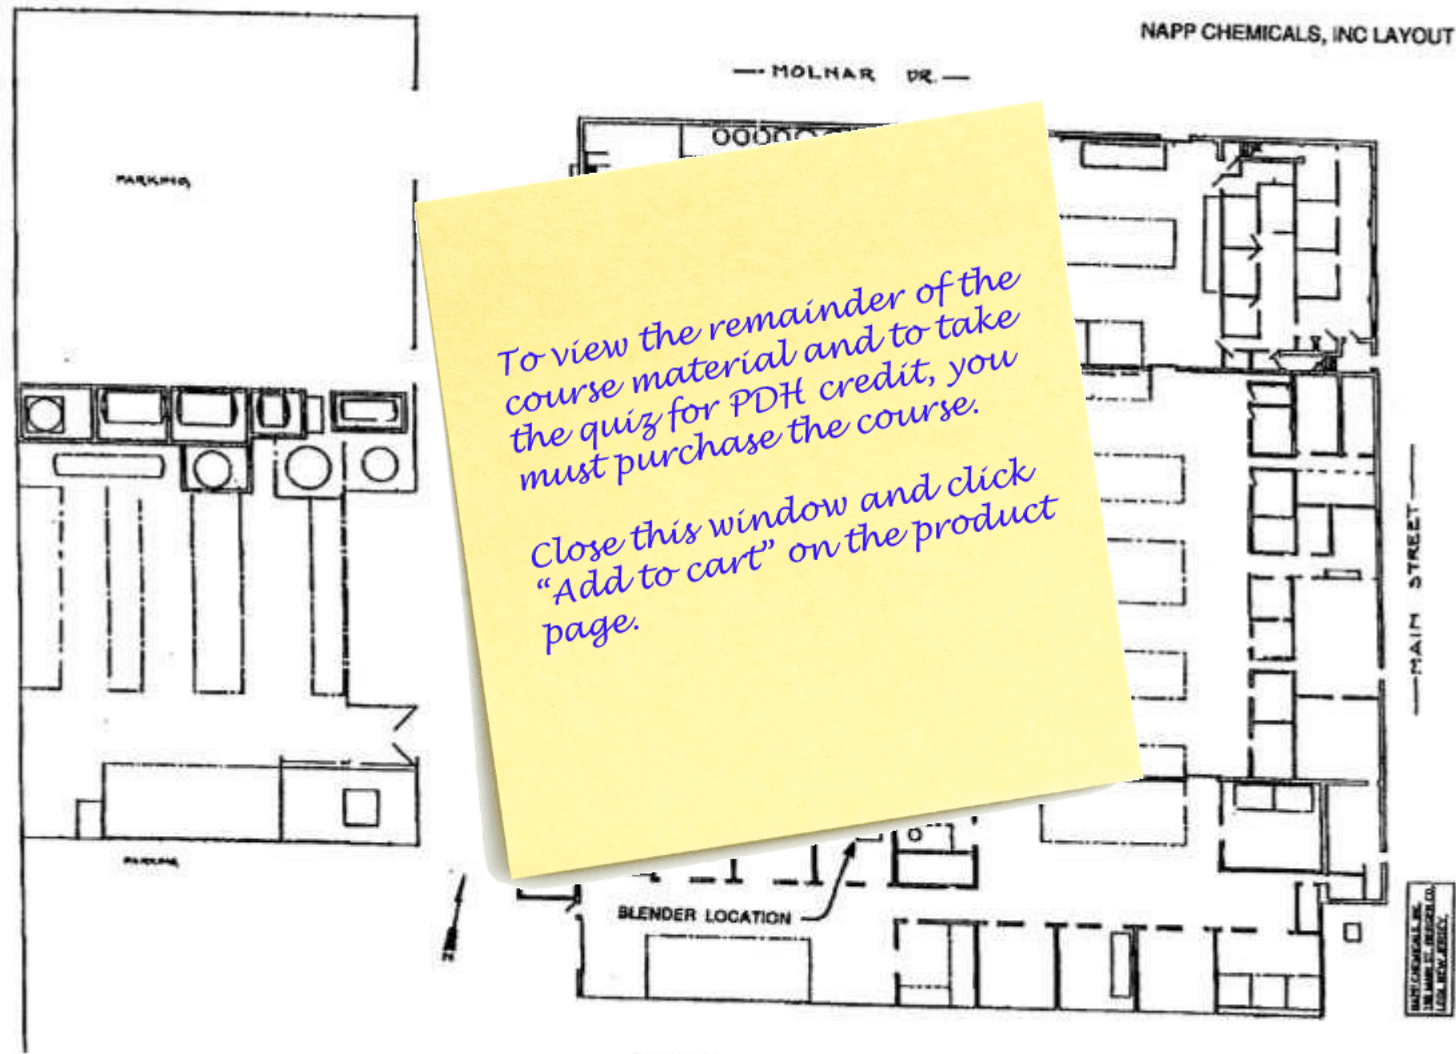
FIGURE 1

The Patterson-Kelley (PK) 125 blender used in the GPA blending operation was located in the PK-125 Blending Room, located in the Pulverizing and Blending Department on the south side of the facility, near the main warehouse area (see Figure 1).
