America's Deadliest Bridge Failure - The Silver Bridge

An Online Continuing Education Course for Engineers

Course Number: ED-2003

James S. Bluma, P.E.

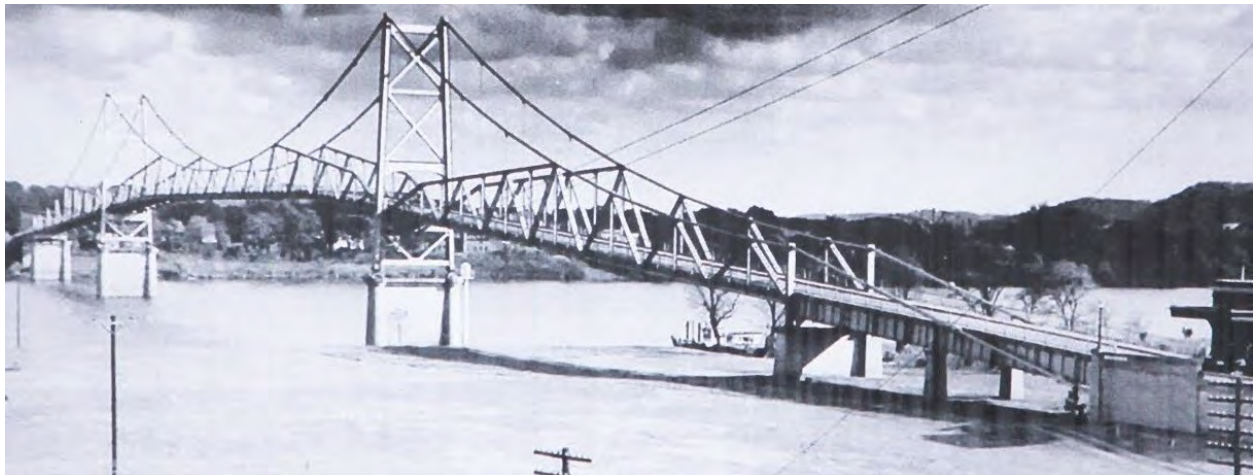
Below, Figure 1: Photograph of the newly completed Point Pleasant Bridge as seen from the Ohio side looking south-east. Storm clouds foretold the heavy rains that would fall later that day, May 30, 1928, during its opening celebrations.

The Point Pleasant Bridge was a 1,460-foot suspension type bridge that spanned the Ohio River to connect highway 35 between Point Pleasant, West Virginia and Gallipolis, Ohio. The bridge had a 700-foot main span and two 380-foot side spans with a 22-foot two-lane roadway and a 5-foot pedestrian walkway. The bridge was unique in many respects and incorporated many first-time applications in the United States. Among these unique applications was the use of aluminum paint to protect the bridge and gave it its silver color causing it to become commonly referred to as the Silver Bridge.

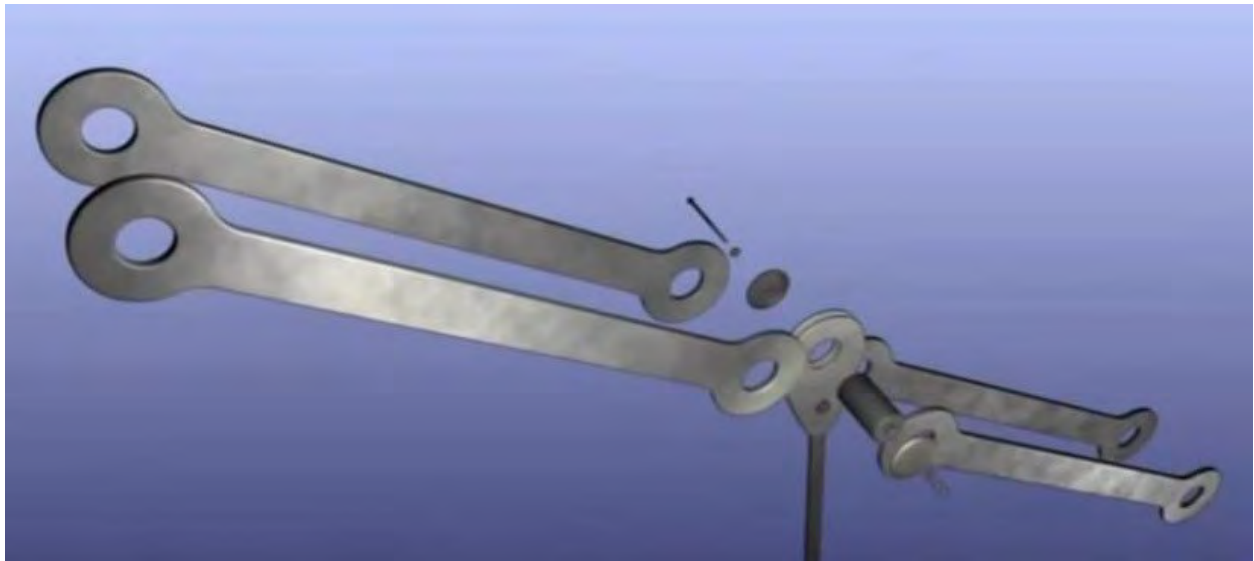
Below, Figure 2: Typical eye-bar assembly used on the Silver Bridge suspension chain.

Included in their winning bid, American Bridge had proposed some changes to Greiner's design which would make the bridge novel and less expensive to build. Rather than suspension cables, it would use "chains" of eye-bars (Figure 2 below). The eye-bar pairs would form a link and there would be 76 of these links on the bridge. The links varied in length from 55 to 44 feet depending on their location and the eye-bars that formed the links would be 1 foot wide and 2 inches thick across the beam section. The eye-bars would be linked together bicycle chain style with 11-inch diameter steel pins passing through 27-inch diameter eyelets at the eye-bar ends to form the main part of the suspension system. From these link pin joints, high strength steel hanger bars would support the bridge deck through its truss work. In addition to the eye-bar chain suspension system, the American Bridge proposal included other novel features that also had not been applied in any bridge in the U.S. before. Because the eye-bar links would join with

a link pin at the top of each tower, the towers could not be firmly affixed to their concrete piers but instead needed to rock or tip on hinged joints at their base to allow for changes in chain length due to varying bridge loads and temperature. Another very notable deviation from convention was the plan by American Bridge that the suspension chains in some places also doubled as the top chord of the trusses that stiffened the roadway deck. Ordinarily, these top chords would be in tension, however, the use of a chain as the top truss chord when combined with the pivoting bridge towers meant that these members could never act in compression and continue to temporarily support the bridge deck in the event of other bridge system failures. Neither of these concepts had been applied in U.S. bridge construction at that time.

American Bridge had used a design load tensile stress of 44,000 psi through the eye-bar beam section which would have provided a theoretical safety factor of 75/44 or 1.7 for these components when using the heat treated 1060 steel. Based purely on cross-sectional areas, the beam section of the eye-bars were considered to be the point of failure should a failure occur. Residual stresses in steel caused by the quenching operation of heat treatment were not fully understood in 1927. The eye-bars used in the Point Pleasant Bridge were heat treated by heating the eye-bars to their austenitizing temperature of 1,600 degrees F and rapidly cooling (quenching) in water. They were then tempered by reheating to 1,175 degrees F and allowed to air cool slowly. This procedure resulted in a non-homogenous micro-structure. The heat-treating procedure caused the resulting material to be characterized as a "slack quenched" steel in which the desired martensite state with its fixed carbon distribution was formed only in a layer .25" to .40" from the eye-bar surfaces and a ferrite-pearlite structure was formed in the interior of the bars. Hardness testing of recovered eye-bars confirmed this with exterior hardness values of 32 – 34 Rc and a material hardness gradually reducing to about 21 Rc near the center. This condition resulted in residual compressive stresses in the outer "shell" of the eye-bars and residual tensile stresses of up to 20,000 psi in the interior of the bars. These effects were most pronounced at the eyelet ends of the bars perhaps due to the greater cross section of the eye-bars in these areas at the time of heat treatment. The eye-bars were made by hot rolling the 1060 steel to the 2-inch thickness and 12-inch width. The eyelet end areas were left thicker during rolling to provide the additional material needed to open die forge the ends of the eye-bars to their finished diameter of

27 inches while maintaining a 2-inch finished thickness. The multi-sized, slightly figure “8” shaped holes for the 1 1/2-inch link pins would be cut after heat treating.
