Engineering Ethics: The Fukushima Nuclear Plant Disaster

An Online Continuing Education Course for Engineers

Course Number: ET-1040

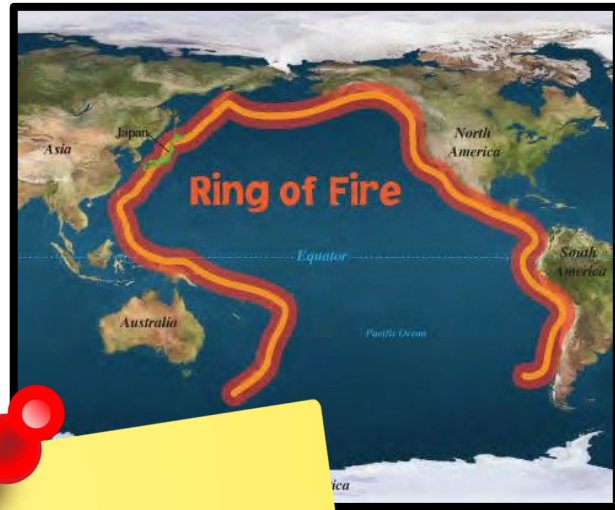
The plant was built on a bluff that was originally 35 meters above ground 10 meters above the basement facilities below.

The bluff was excavated to mitigate earthquake tremors. However, the siting decision. Very heavy machinery and the low level provided seawater pumps for the cooling

The Japan Times cited Hiroshi Kaburaki, then deputy head of the TEPCO’s construction office at the Daiichi plant, writing in a 1969 technical magazine: “We decided to build the plant at ground level after comparing the ground construction costs and operating costs of the circulation water pumps.”^x

Planners did consider the possibility of a tsunami. At the time the plant was constructed, TEPCO estimated that the maximum possible tsunami would be only 3.1 meters. After new information emerged, the facility was upgraded to withstand a tsunami of 5.7 meters in 2002.
