The Pressure Vessel Explosion at Bayer Chemical Plant

An Online Continuing Education Course for Engineers

Engineering Ethics: Pressure Vessel Explosion at Bayer Chemical Plant

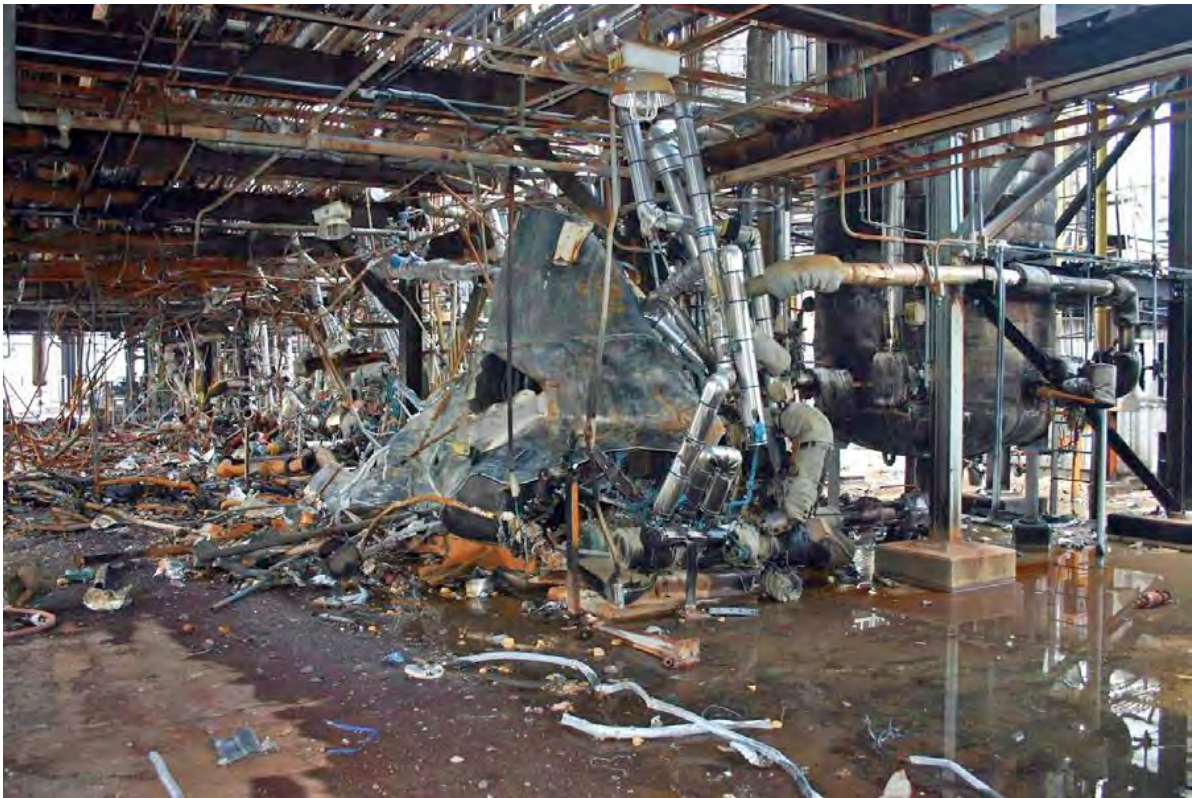
Equipment destruction along the trajectory of the residue treater vessel; the deformed shell of the vessel is visible at the center of the photograph. (Source: CSB.)

Debris was thrown hundreds of feet. The treater was torn apart and the explosion ripped out piping, electrical conduit and a steel support column. The unit control building and other structures were damaged.

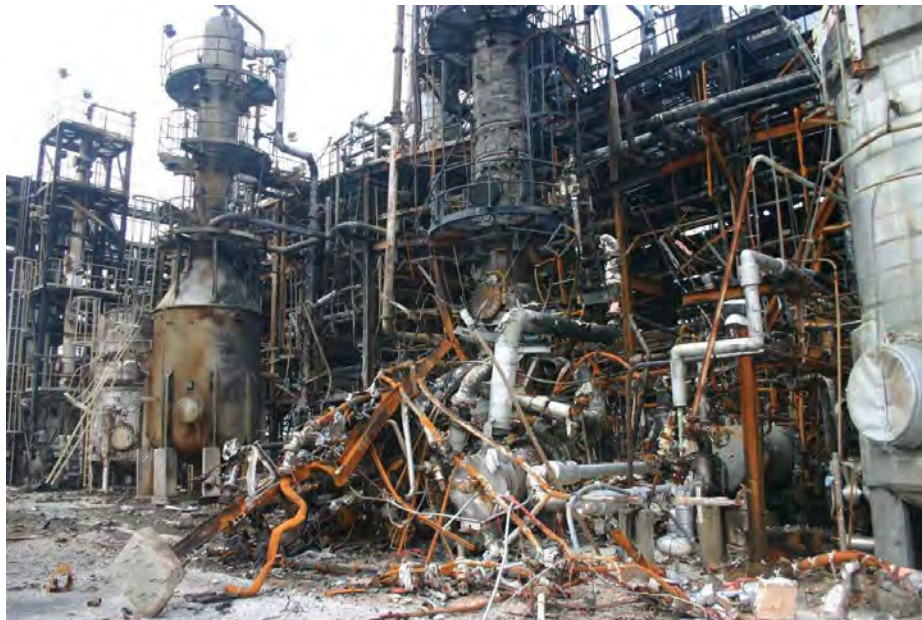
The explosion ripped out piping, electrical conduit and damaged structures in the facility. (Source: CSB Report.)

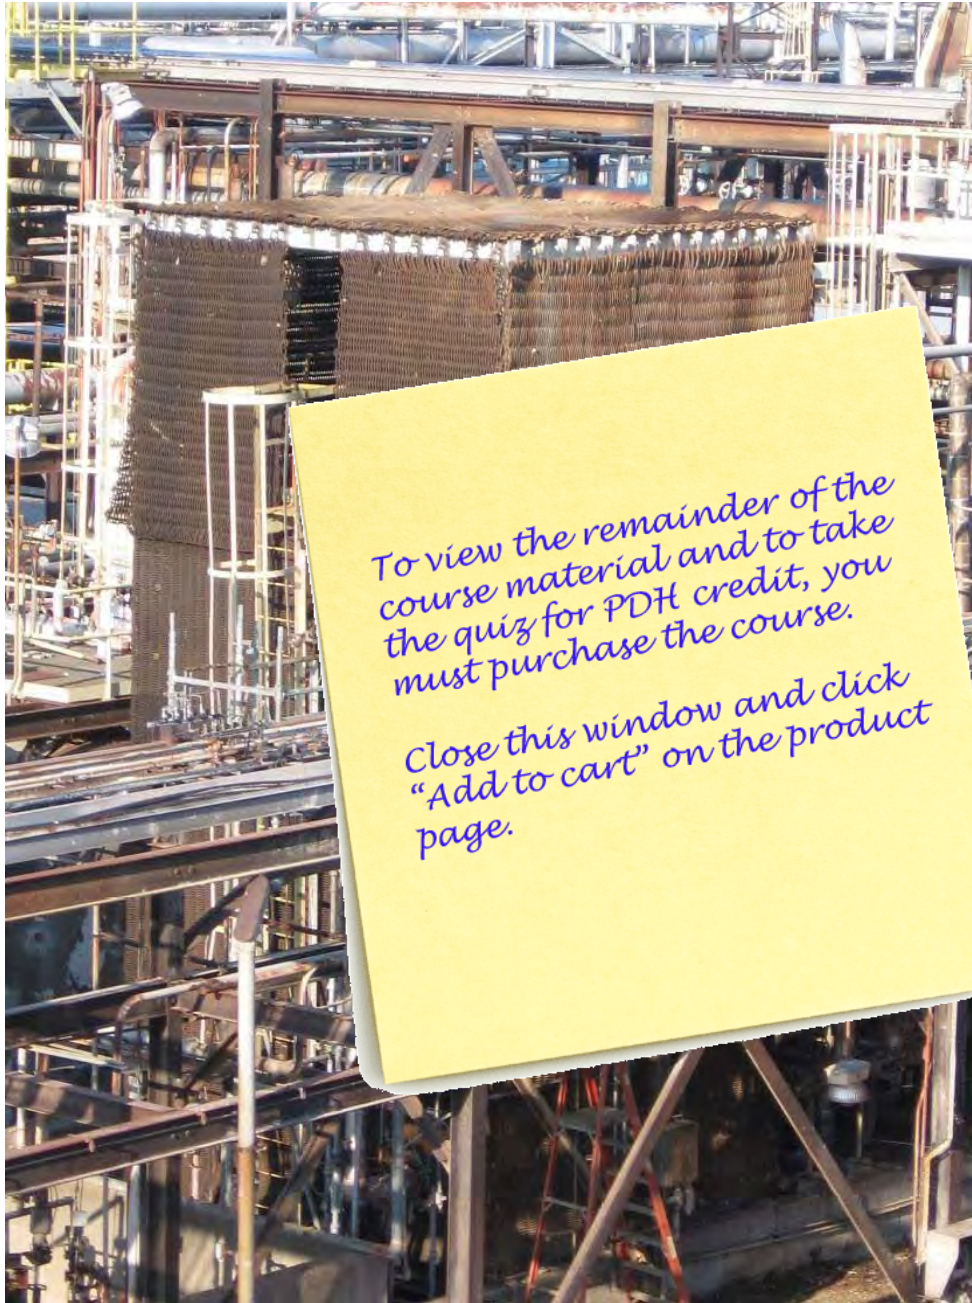
MIC day tank shield blanket structure. (Source: CSB.)

A 6,700 gallon methyl isocyanate (MIC) “day tank” about 70 feet away was hit by debris, but didn’t sustain damage. It remained shielded from the heat of the conflagration by a steel blanket.
