Hot-Dip Galvanizing for Corrosion Protection

An Online Continuing Education Course for Engineers

Course Number: MA-3002
Credit: 3 Hours / 3 PDH / 3 CPD

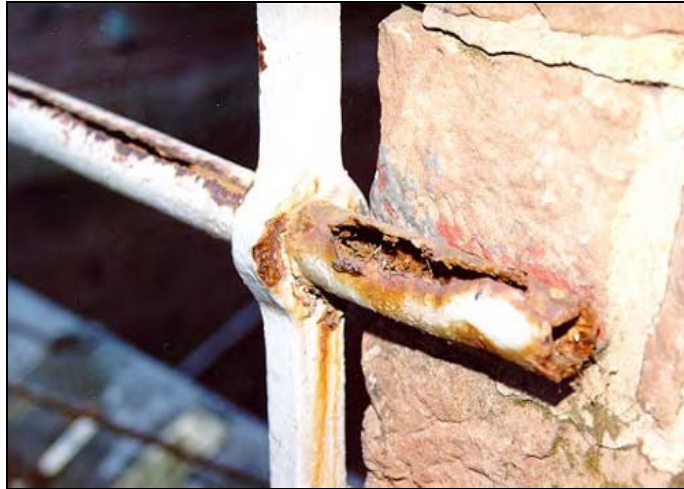
Pictured here is an obvious lack of maintenance of this corrosion prevention system — leading to ultimate project failure with apparent safety concerns.

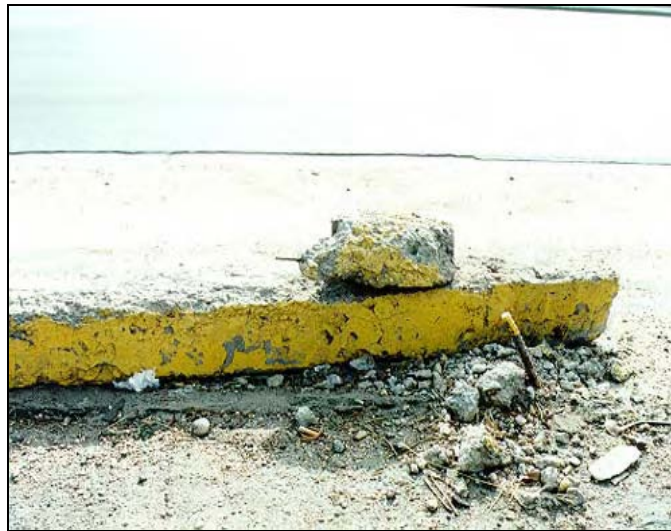
This is a very common sight — the complete failure of parking blocks due to unprotected reinforcing steel corroding.

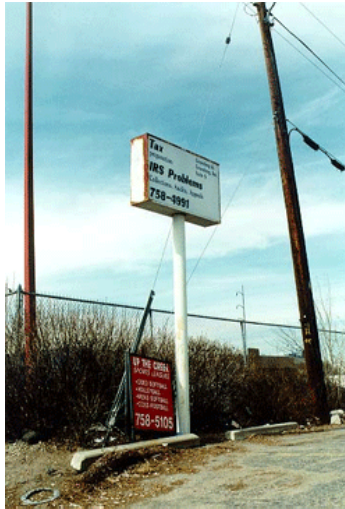
This sign says "IRS Problems," but it clearly indicates "Corrosion Problems!" This sign shows the common occurrence of corner and edge corrosion, where, with a barrier corrosion protection system such as the one seen here, the paint tends to be thinner.

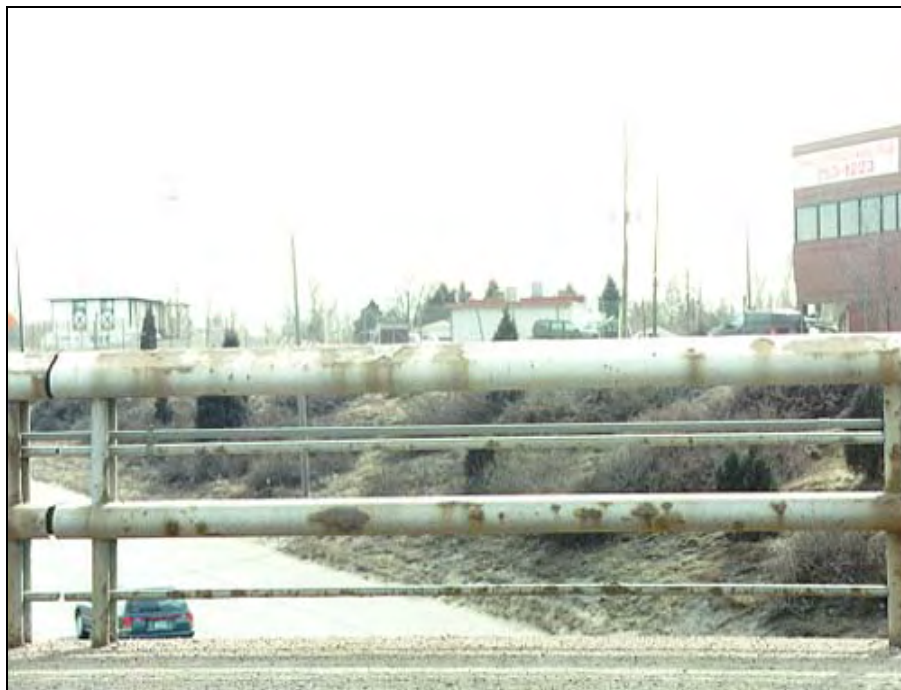
This painted railing shows severe red-rust clumping. Not only is this unsightly, but it is extremely hazardous because the rusting is so extensive the railing is completely deteriorated in many locations.

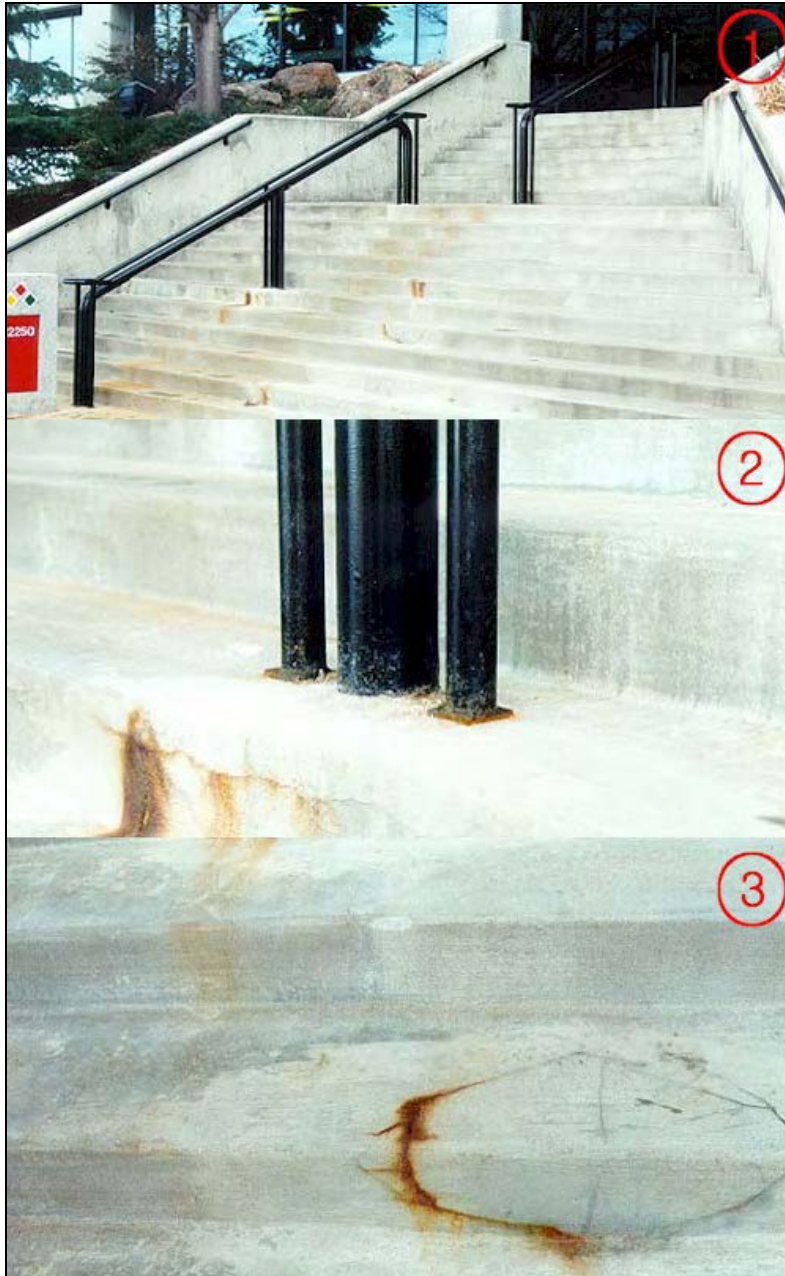
This series of photos depicts two different corrosion situations: First, the concrete steps show staining and cracks in different areas. In the third photo, it is apparent the concrete was patched, which is an obvious repair of spalled concrete. Unfortunately, the patched area has stained and cracked again. Second, while it's difficult to see in the photos, the railing going up the steps is painted-over black steel with visible blistering, peeling, and rusting.
