Earthquake Design Considerations for Office, Retail, Light Industrial, Healthcare, School and University Buildings

Course Number: S-4010

DESIGN AND PERFORMANCE ISSUES RELATING TO COMMERCIAL OFFICE BUILDINGS

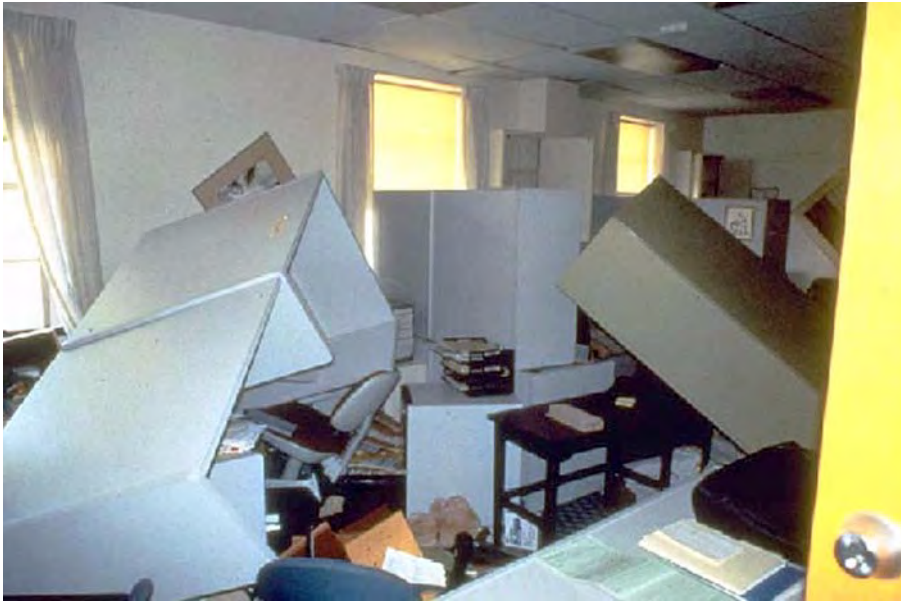
Figure 6-1 Typical earthquake damage to contents and nonstructural components in a modern office building. (photo courtesy of the Earthquake Engineering Research Institute)

The seismic performance of modern office buildings designed to recent codes (adopted since the late 1970s) has been good as far as providing life safety. However, the recognition by building owners that satisfactory life-safety code-level performance may still encompass considerable damage (see Figure 6-1), along with repair costs and possible business interruption of the building for weeks or even months, even in a moderate earthquake, suggests that some performance-based design strategies may be useful.

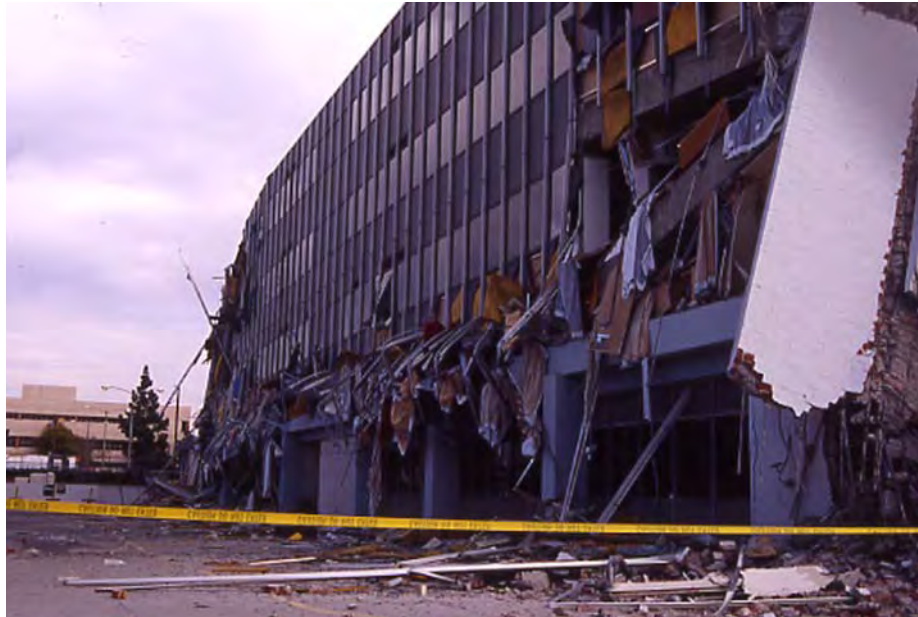
Figure 6-2 Exterior view of medical office building severely damaged by the 1994 Northridge earthquake. (C. Arnold photo)

Where severe structural damage has occurred in commercial office buildings, it has generally been to older buildings, often the result of configuration irregularities. Figure 6-2 shows an older medical office building, which had a vertical irregularity that caused one floor to pancake during the 1994 Northridge earthquake in Southern California; a failure resulting from inadequate attachment of heavy nonstructural walls in an older 5-story office building is shown in Figure 6-3.

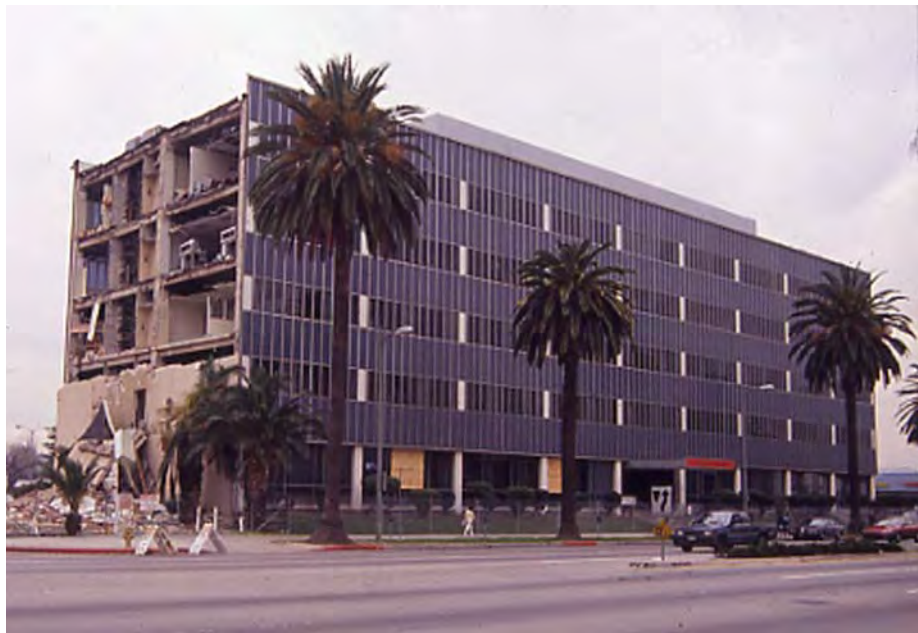
Figure 6-3 Partially collapsed end-wall in 5-story office building caused by severe earthquake ground shaking. (C. Arnold photo)
