6 Hours from Catastrophe – The Hartford Civic Center Collapse

An Online Continuing Education Course for Engineers

Course Number: ED-2002

James Bluma, P.E.

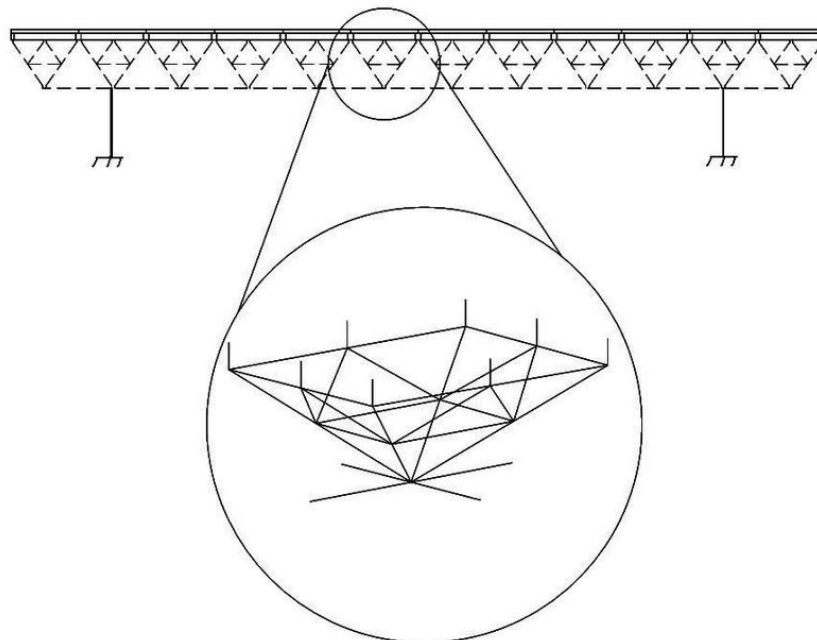
Above, Figure 2: General design of space frame truss system used in the Hartford Civic Center arena roof with pyramidal module enlarged. Two of the four pylon legs supporting the roof are indicated 45 feet from each end.
