# Seismic Design - Evaluation and Retrofit of Existing Buildings

An Online Continuing Education Course for Engineers

**Course Number: BD-3011**

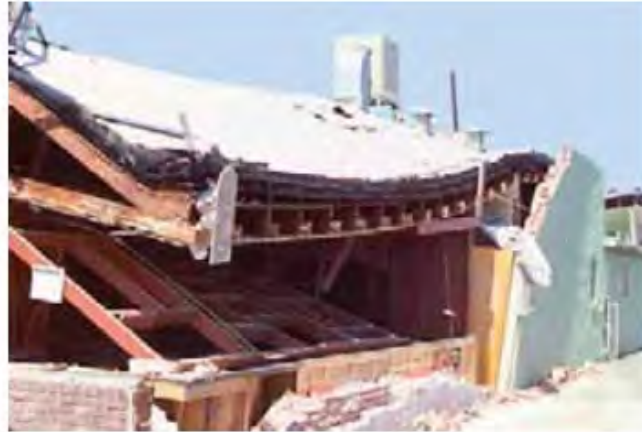
Figure 1: Example of buildings with no code design. Damage shows classic URM deficiencies.

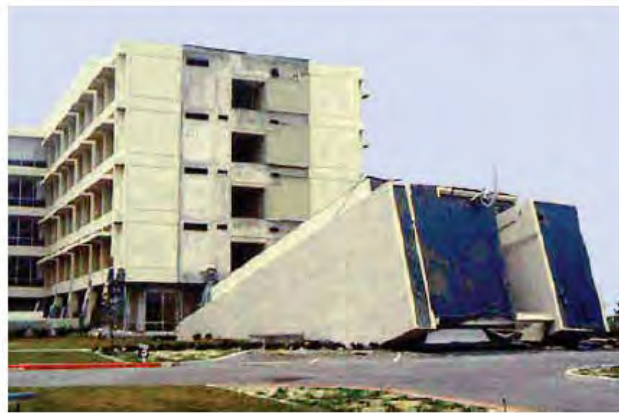
Figure 2: Olive View Hospital. A brand new facility that was damaged beyond repair in the 1971 San Fernando earthquake due to a shaking intensity that exceeded what was expected at the site and a design that, although technically complying with code at the time, contained several structural characteristics now considered major deficiencies. The lateral system contained nonductile concrete frames, discontinuous shear walls, and a significant weak story.

Similar to advancements in structural analysis and the understanding of building performance, enormous advancements have been made in the understanding of ground motion, particularly since the 1950s and 1960s. The seismicity (that is, the probability of the occurrence of various-sized earthquakes from each source) of the country, the likely shaking intensity from those events depending on the distance from the source and the local soil conditions, and the exact dynamic nature of the shaking (the pattern of accelerations, velocities, or displacements) are all far better understood. These advancements have caused increases in seismic design forces from a factor of 1.5 in regions very near active faults (on the West Coast) to a factor of 2 to 3 in a few other areas of the country (e.g. Utah; Memphis, Tennessee). The damage to the first Olive View Hospital (Figure 2), in addition to other issues, was a result of inadequate zoning.

Current codes contain many rules to minimize configurations that could cause dangerous nonlinear response, as well as special design rules for elements potentially affected (e.g., columns supporting discontinuous shear walls). Olive View Hospital featured a weak first story in the main building, causing a permanent offset of more than one foot and near collapse; discontinuous shear walls in the towers caused a failure in the supporting beam and column frame, resulting in complete overturning of three of the four towers. Figure 4 shows a typical "tuck-under" apartment building in which the parking creates a weak story.

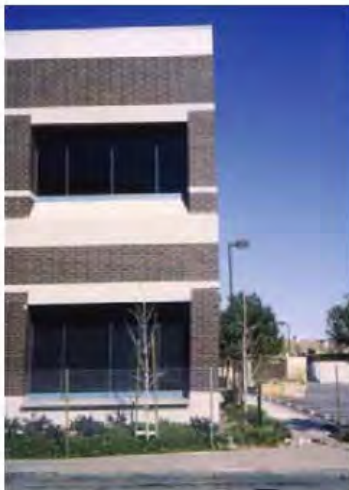
Figure 3: An example of a recently designed building with seismic deficiencies not understood at the time of design. In this case, the deficiency was "pre-Northridge" moment-frame connections, which proved to be extremely brittle and unsatisfactory. Hundreds, if not thousands, of these buildings were designed and built in the two decades before the Northridge earthquake (1994).

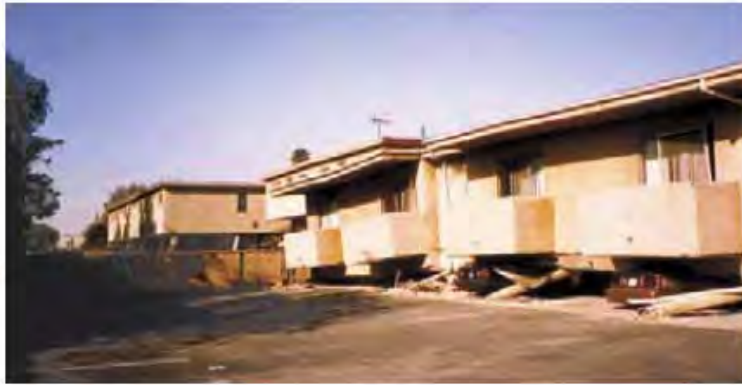
Figure 4: A 1970s building type with a deficiency not prohibited by the code at the time—a tuck-under apartment with parking at the ground level, creating a weak story. Many of these buildings collapsed in the Northridge earthquake. Sixteen deaths occurred in the Northridge Meadows apartments, or 42% of those directly killed by the earthquake.

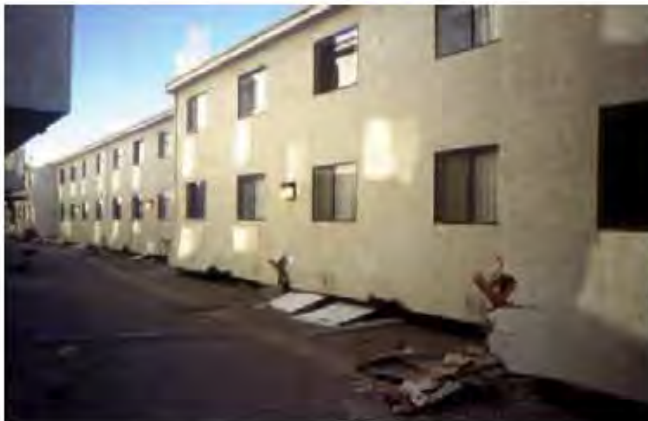
Figure 5: A tuck-under similar to Figure 8-4, but much more modern and designed at a time when the weakness of the parking level was more understood. In this case, the detailing of the small wood shear walls at that level was poor. This practice created another set of deficient “existing” buildings.
