# Engineering Ethics: The Minnesota I-35W Bridge Collapse

An Online Continuing Education Course for Engineers

Edward P. Brunet, Jr., P.E.

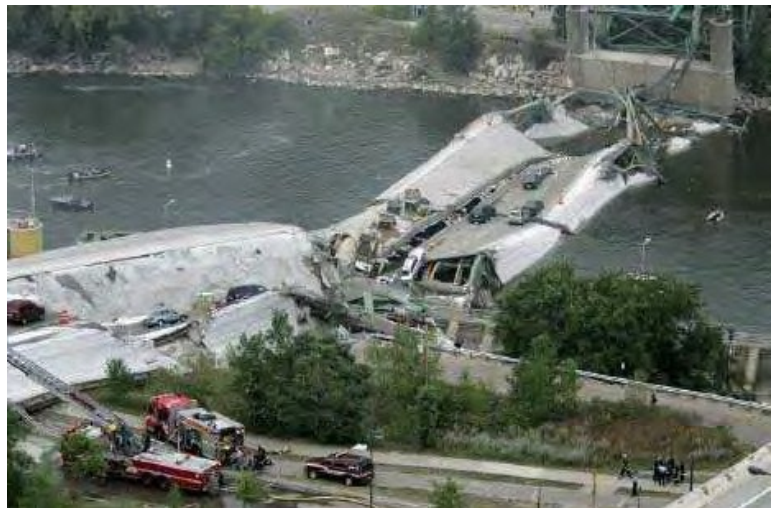
Figure 2: Collapsed north section of bridge. (Source: NTSB.)

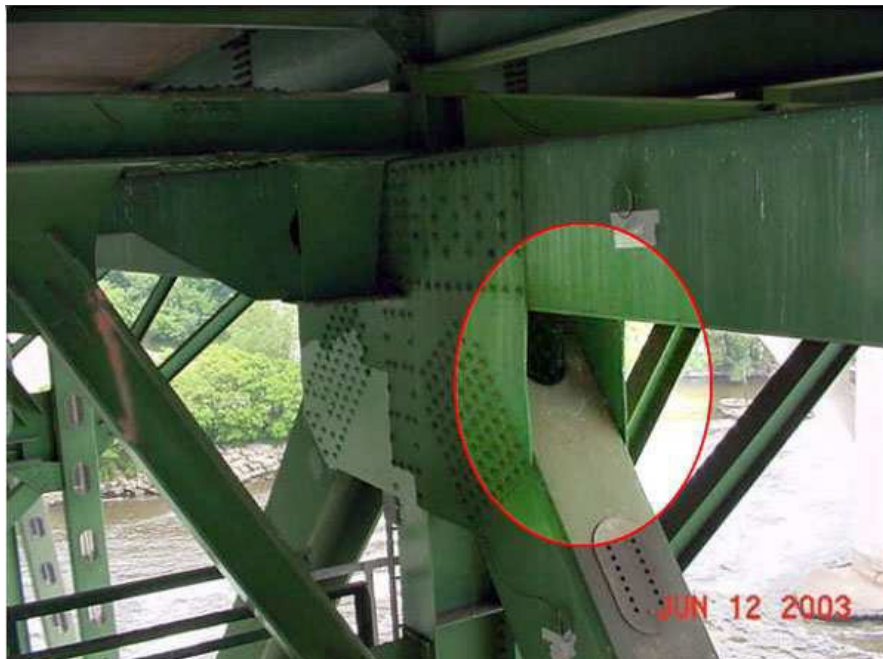
Figure 3: Bowed and significantly distorted gusset plate. (Source: NTSB.)

Over the years, the design and load bearing capacity of the ill-fated connector (gusset) plates were never questioned, based on the prevailing wisdom that gusset plates are very conservatively designed and are considered the strongest part of the truss unit. (Figure 3 below.) For some reason, the original design was apparently never checked; the American Society of State Highway and Transportation Officials (AASHTO) and state guidelines overlooked the load-bearing capacity of gusset plates; the load bearing capacity of the plates was not considered when the load rating was recalculated during bridge modifications; and multiple inspectors ignored bows and significant distortion in the aging plates.
