Explosion at the Dupont Buffalo Facility

An Online Continuing Education Course for Engineers

Explosion at the DuPont Buffalo Facility

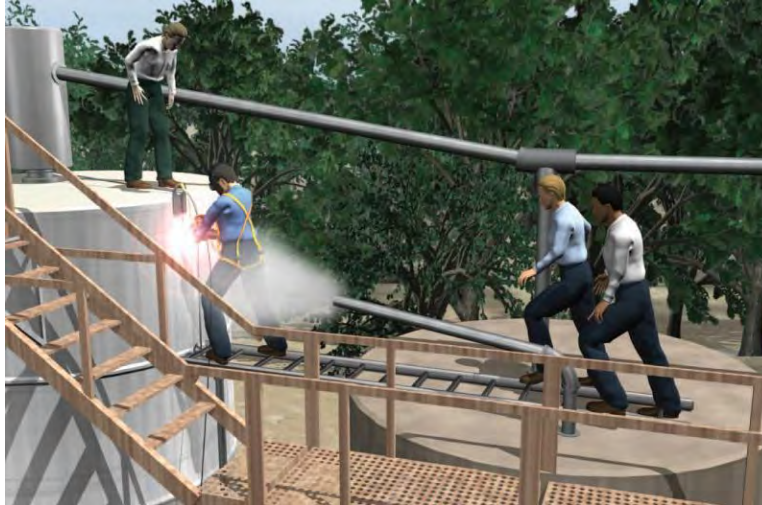
Depiction of hot work from the CSB's 2008 safety video "Death in the Oilfield." (Source: CSB.)

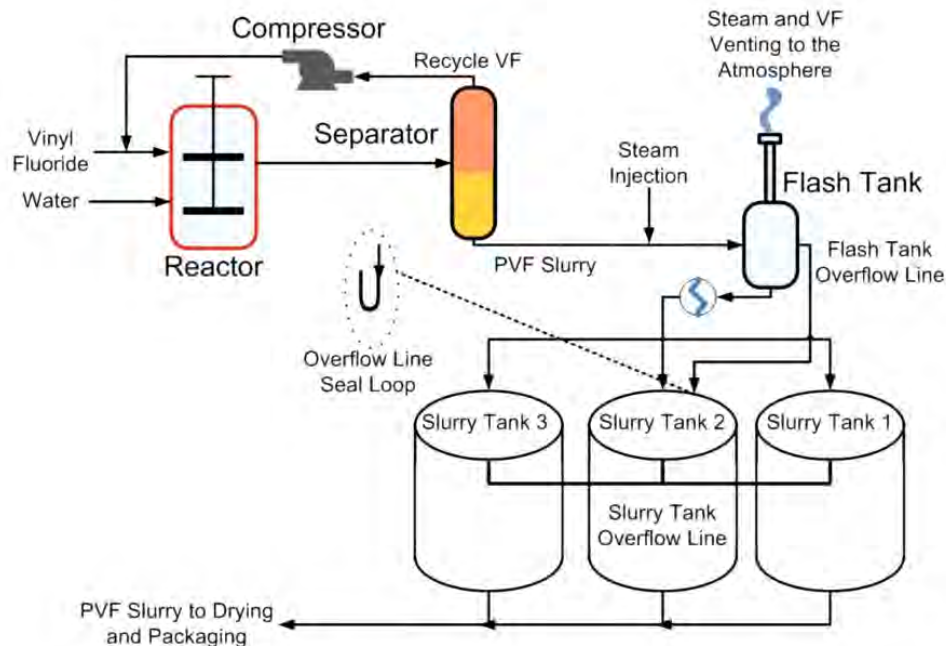
PVF process flow diagram. (Source: CSB.)

DuPont produces VF at a different facility and transports it to the Buffalo plant for storage. There, the VF gas is mixed with water and pumped from storage tanks to a reactor. In the reactor, VF undergoes a process to produce a mix of polymer and water PVF slurry and unreacted VF. The mix is sent to separators to remove the unreacted VF, which is pumped back to the reactor.

Any remaining VF is removed from the PVF by a steam injection process that vaporizes the residual VF. The heated PVF slurry is moved through a flash tank, where the steam and vaporized VF is released, and on to one of the three storage tanks. The slurry stores in the tank to settle before being pumped out of the bottom of the tank and sent to another reactor to be transformed into a polymer powder. The dried powder is transported to a mixing area to produce Tedlar.

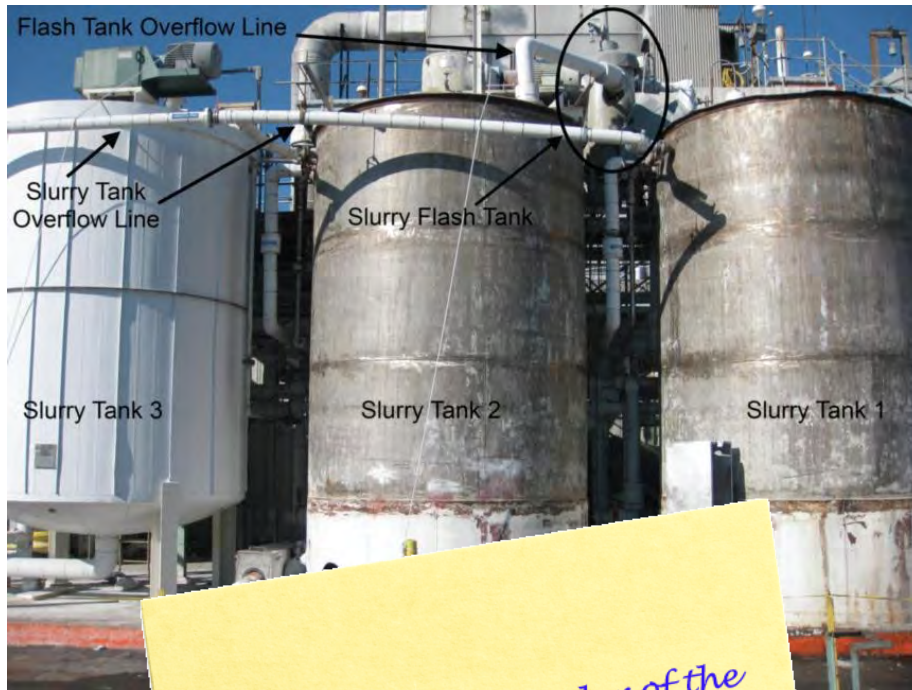
The flash tank and three slurry storage tanks are housed in an area next to the Tedlar manufacturing building.

The slurry tanks are 11 feet high and hold around 10,800 gallons. The shell and top are made of stainless steel.

The slurry tank feed and discharge lines are located at the tops of the tanks and bleed off to a common equalizer line near one tank from another when the third is used. Each tank has an agitator and covers cover the top.
