Terror In The Tunnel: The Xcel Energy Cabin Creek Fire

An Online Continuing Education Course for Engineers

Course Number: H-1009

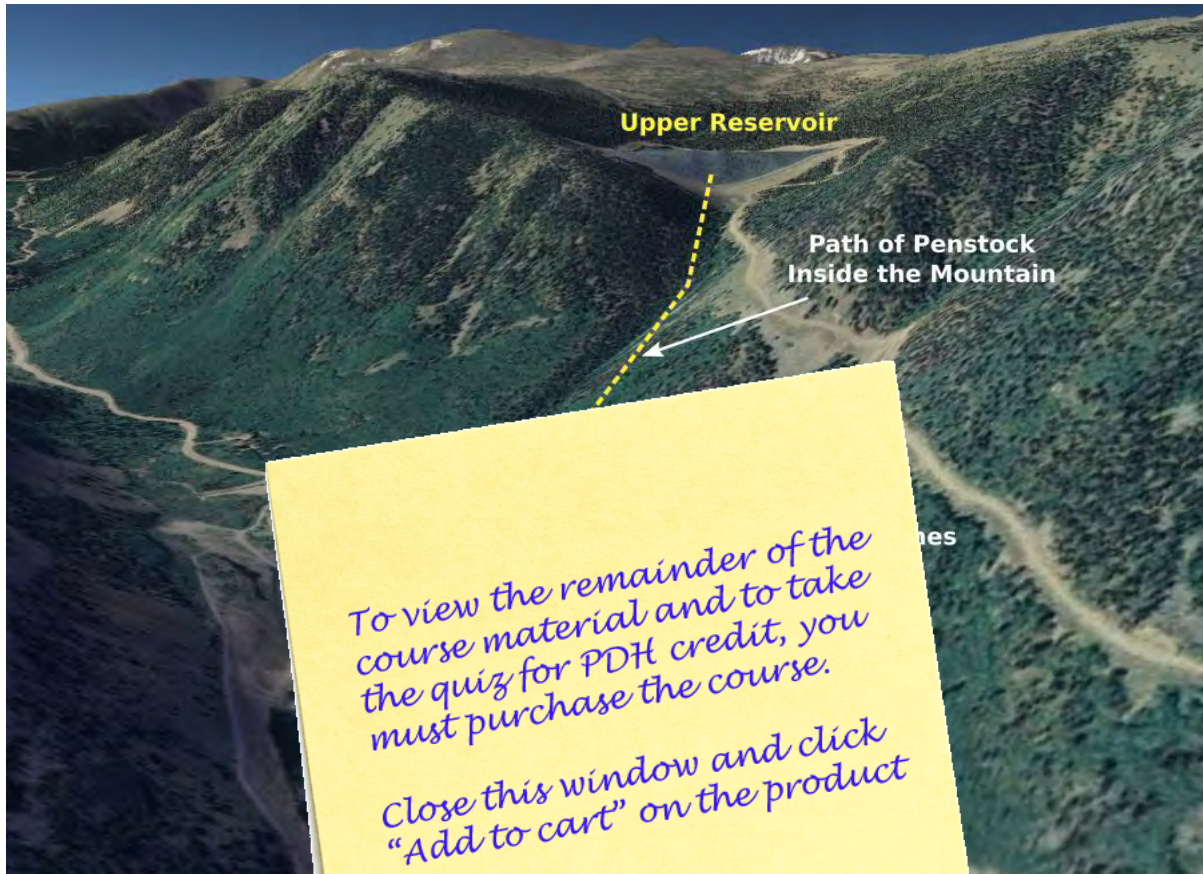
Diagram of the Cabin Creek Plant Penstock. Source: Xcel Energy, Inc. (Xcel Energy, Inc. 2013). 5B.
