Tilted Buildings: Causes and Solutions

An Online Continuing Education Course for Engineers

Course Number: S-3023

Ibrahim M. Metwally, P.E.

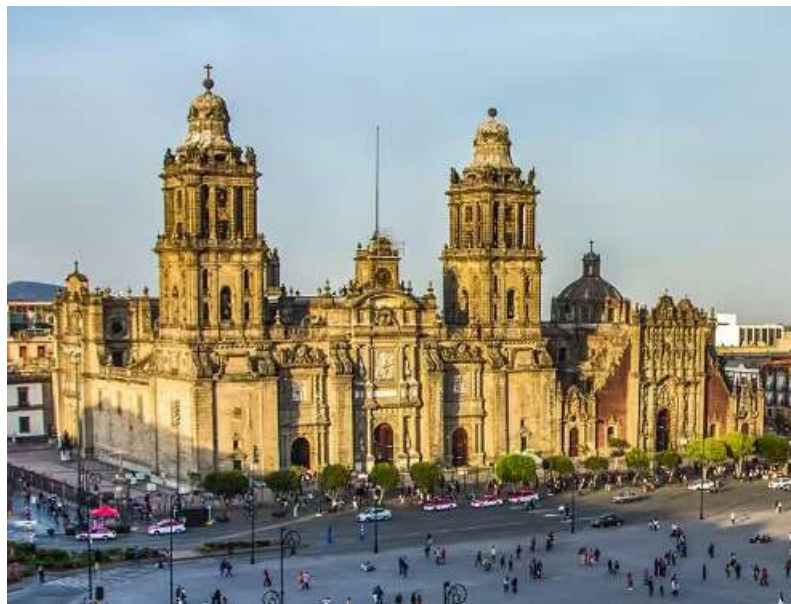
Fig.1- Mexico Metropolitan Cathedral in Mexico City

- 1) *Mexico Metropolitan Cathedral in Mexico City*(Fig.1), which was constructed between 1573 and 1813. The object has been settling for ages, during which many (ineffective) attempts were made to correct the failure. The maximal inclination occurred in 1989 when the difference in lowering the opposite elevations (i.e., western tower and apse) reached 2.4 m. In 1995, the inclination to the south equaled from 0.11o to 1.15°, and towards the east - from 1.72° to over 2.86°. Building works in Mexico City have always been an incredibly difficult task as almost all the area is underlain by soft lacustrine clays with high levels of saturation, low shear strength, and exceptionally high compressibility.

The subsidence was caused by the change in groundwater conditions as the result of excessive exploitation of aquifer layers under the city and the fast lowering of the groundwater table (from 3.5 m in 1972 to 7.4 m in 1990). However, according to Puzrin et al. [2], the most significant factor for the cathedral's tilting was the uneven compressibility of the subsoil due to the differences in the stress history of the ground. The city was basically the Aztec empire with multiple historic constructions (e.g., pyramids), which were demolished in the 16th century after the Spanish conquistadores' arrival. When building the current Mexico City, secondary consolidation of the ground was initiated in the places of the previous Aztec buildings, while in the other places, primary consolidation was active. The historical data revealed that the cathedral was built partially on the remains of an Aztec temple. Thanks to the stabilization work (under excavation) conducted in 1993 – 1998, the inclination of the walls decreased by 0.34° from an average initial value of nearly 1.15° (the rectification procedure is described below).

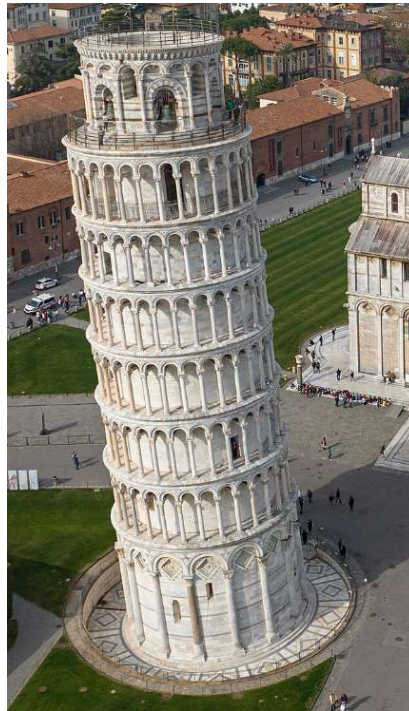
Fig. 2- The Leaning Tower of Pisa

The inclination of another very well-known object is the leaning tower of Pisa (Fig. 2), whose maximal inclination reached 5.5° , was also connected with the presence of compressible cohesive soils and the variation of the piezometric levels of groundwater on both sides of the object and so, the uneven consolidation of marine clays in the profile. It is worth mentioning that this object probably avoided the earlier failure thanks to the long-term breaks during its construction, which caused the gradual dissipation of the accumulated excess pore pressure in the clays. Some of the methods applied for the stabilization of the tower are described shortly in the next paragraphs.
