Combustible Dust Explosions at Gallatin Plant

An Online Continuing Education Course for Engineers

Course Number: H-1005

Edward P. Brunet, Jr., P.E.

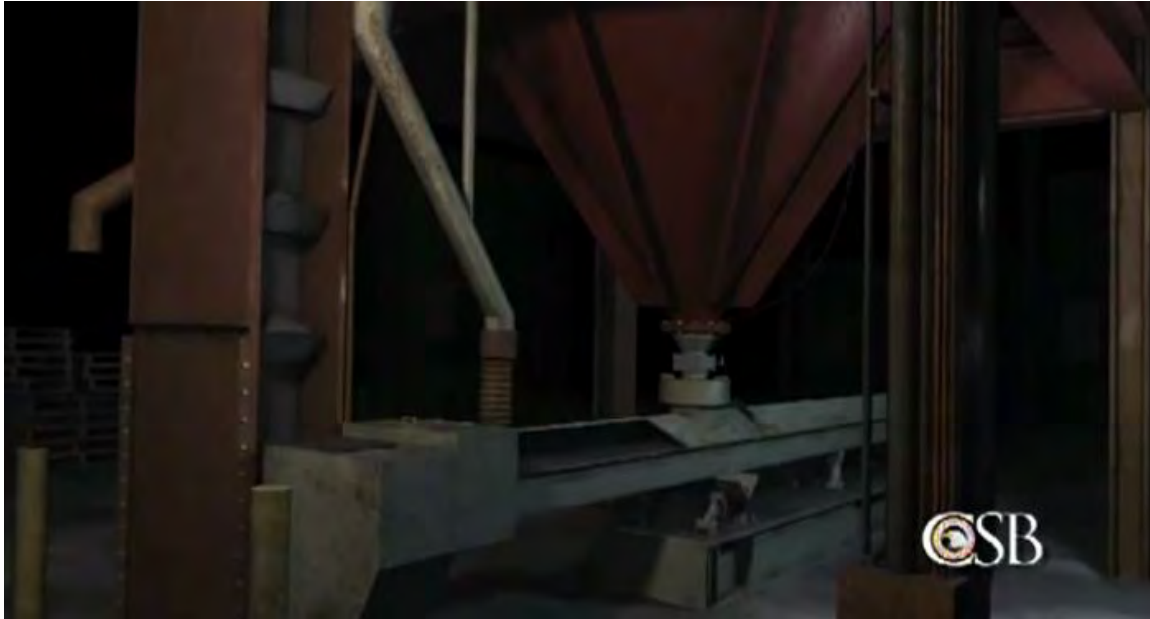
Iron is transported through the plant by a system of conveyors and bucket elevators. (Source: CSB.)

Iron is transported through the plant by a system of conveyors and bucket elevators.

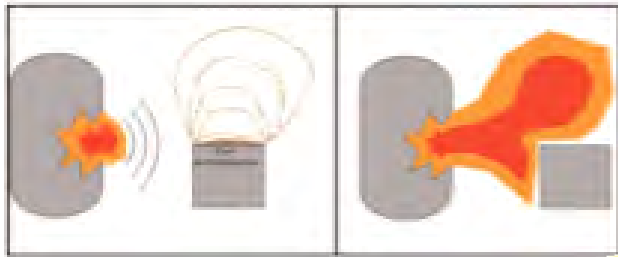
Initial Explosion

Secondary Explosion

(Source: OSHA.)

“In addition to the familiar fire triangle of oxygen, heat, and fuel (the dust), dispersion of dust particles in sufficient quantity and concentration can cause rapid combustion known as a deflagration. If the event is confined by an enclosure such as a building, room, vessel, or process equipment, the resulting pressure rise may cause an explosion. These five factors (oxygen, heat, fuel, dispersion, and confinement) are known as the “Dust Explosion Pentagon”. If one element of the pentagon is missing, an explosion cannot occur.”⁹

If the primary explosion dislodges additional dust that may have accumulated, a catastrophic secondary explosion or series of explosions may occur. OSHA notes that the secondary explosions “can be far more destructive than a primary explosion due to the increased quantity and concentration of dispersed combustible dust. Many deaths in past accidents, as well as other damage, have been caused by secondary explosions.”¹⁰
